6.0.0 HOUSING QUALITY REPORT

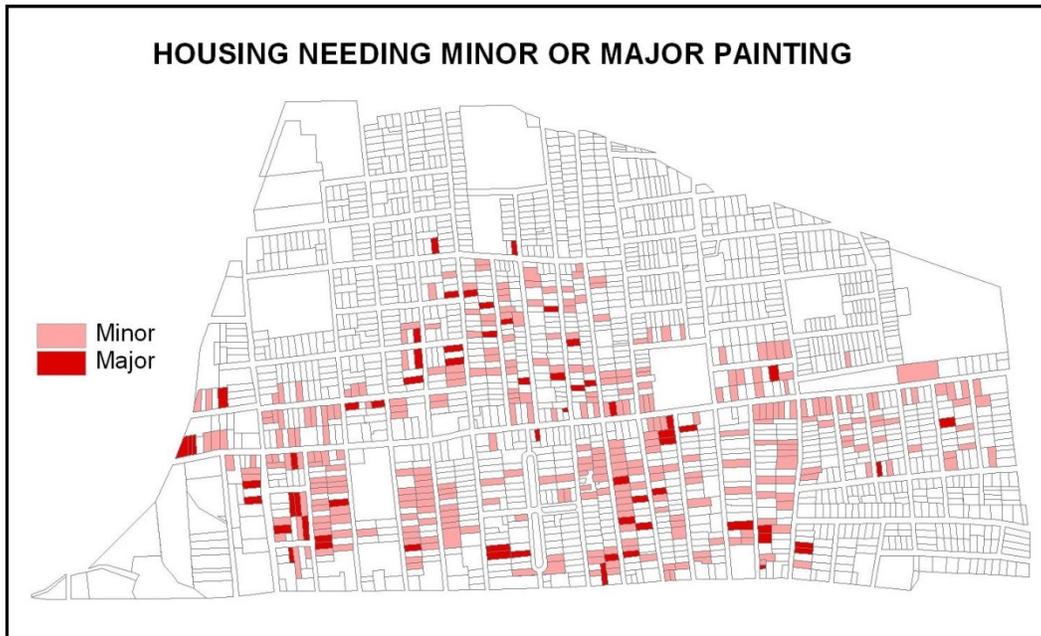
Figure 6.2 Properties Needing Minor or Major Painting

The map of housing in need of paint (Figure 6.2) and the map of housing in need of a siding repair (Figure 6.3) illustrate that these two variables are often found together and that these problems occur in clusters. This could mean that if a house needs painting it probably needs some siding repair and the houses on either side probably need either or both of these repairs as well. This finding exemplifies the impact that targeted programs may have.

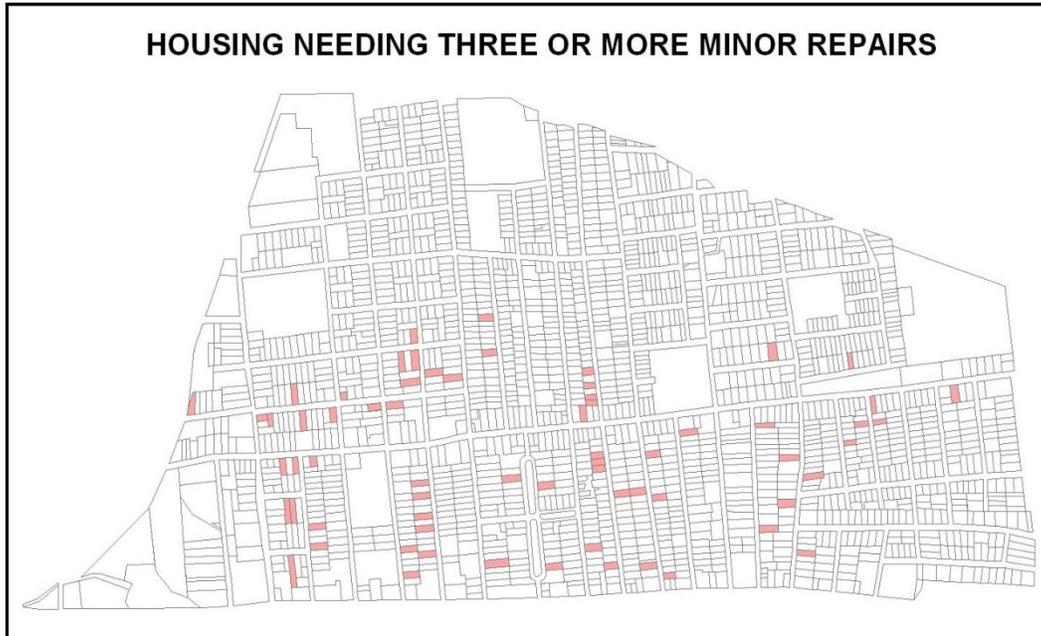
Figure 6.4 Properties Needing Three or More Minor Repairs

Houses needing three or more minor repairs (Figure 6.4), often including paint and siding, are starting to show signs of long-term neglect. Timely intervention could improve the condition of the housing stock. Houses exhibiting these needs are widely scattered across the East Side, however, they tend to form loose clusters and could be targeted for repair in a 'neighborhood' fashion.

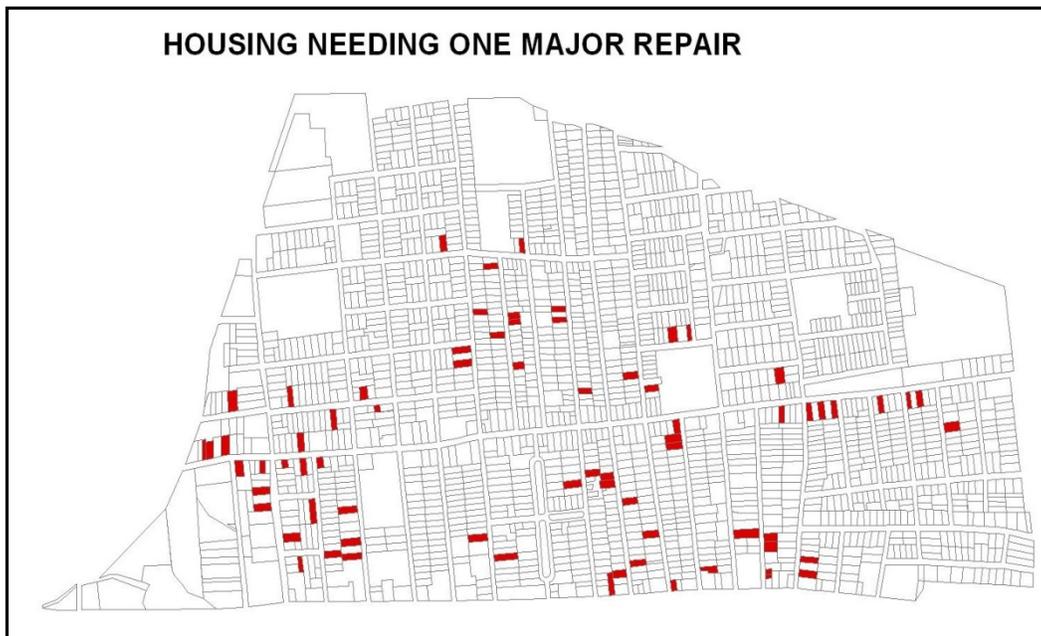
Figure 6.5 Properties Needing One Major Repair

Similarly, houses needing one major repair (Figure 6.5), and often a minor repair or two, are also showing signs of neglect but these structures are in more immediate need for intervention. Again, these houses tend to form loose clusters.

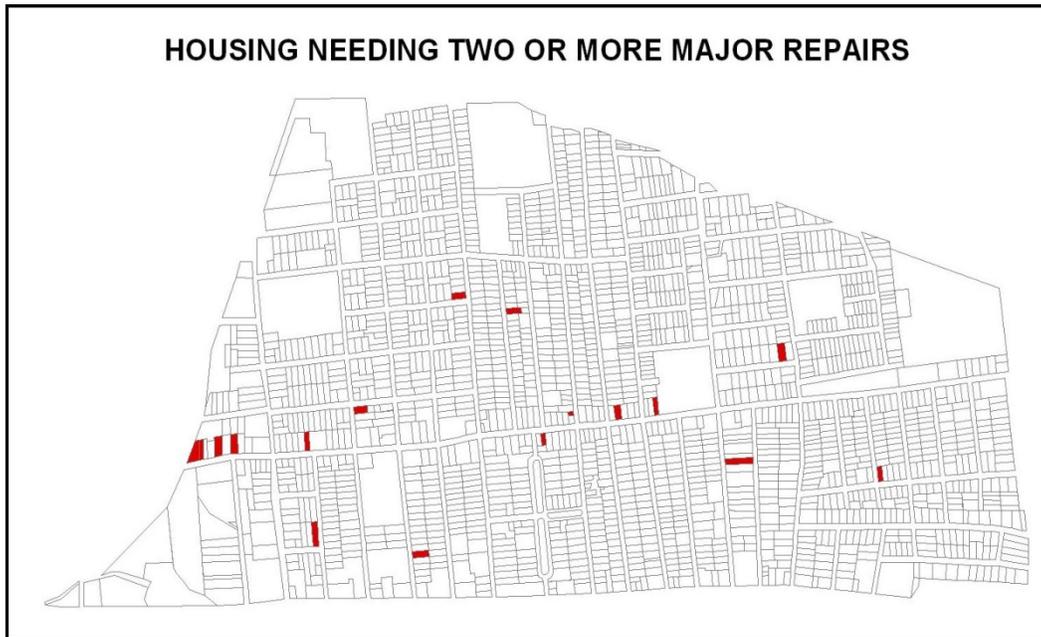
Figure 6.6 Properties Needing Two or More Major Repairs

Finally, houses needing two or more major repairs and often several minor repairs are so deteriorated that it is probably in the City's best interest to have these buildings demolished. For the most part these

houses are scattered across the East Side with no apparent clustering (Figure 6.6). However, there is a cluster at the western end of the Robinson Street Corridor. This is considered by the residents as one of the “Gateways” to the East Side and as such this deteriorated housing stock should be given immediate attention.

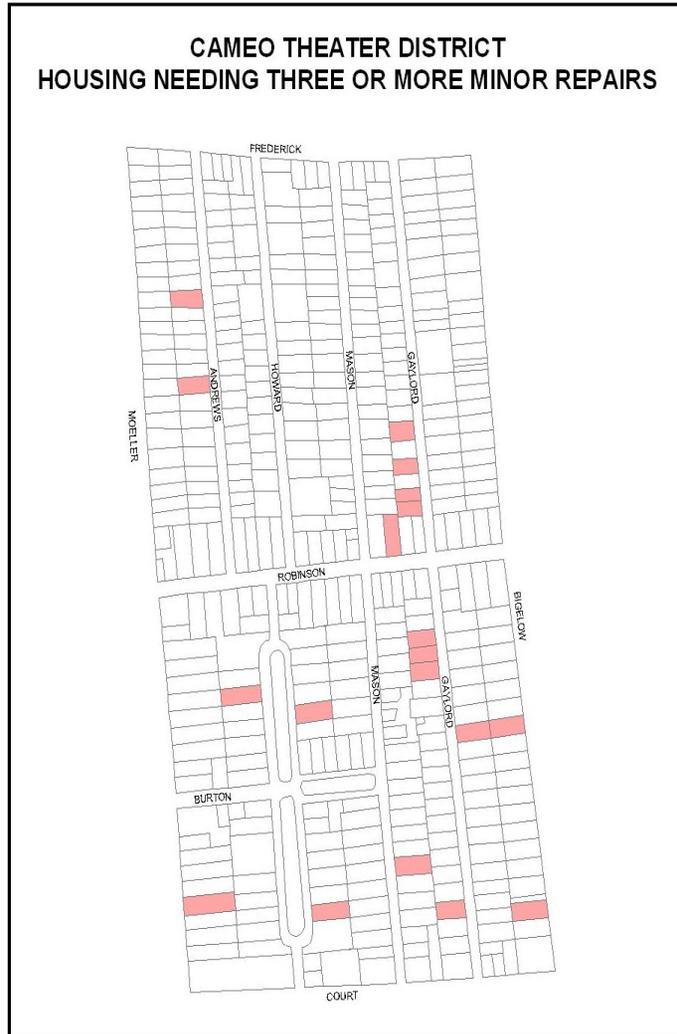
Figure 6.9 Properties Needing Three or More Minor Repairs

Findings from the Neighborhood Assemblies and the resident and business surveys lead to the creation of the Cameo Theater target area for increased focus and analysis (See Section 10.0). The following maps and analysis will focus on the housing quality in the Cameo Theater area. Generally speaking the observations made in the previous section are also true of the Cameo Theater Area. Houses needing paint or siding repair are scattered throughout the area but show some clustering (Figures 6.7 and 6.8), again allowing for a targeted approach for rehabilitation. It is interesting to note that the houses on Howard Avenue, a street that has been closed to through traffic from Court Street, have been very well maintained. There are many fewer houses that need three or more minor repairs, or one major repair. They are scattered around the focus area, with several adjacent to one another (Figures 6.9 and 6.10).

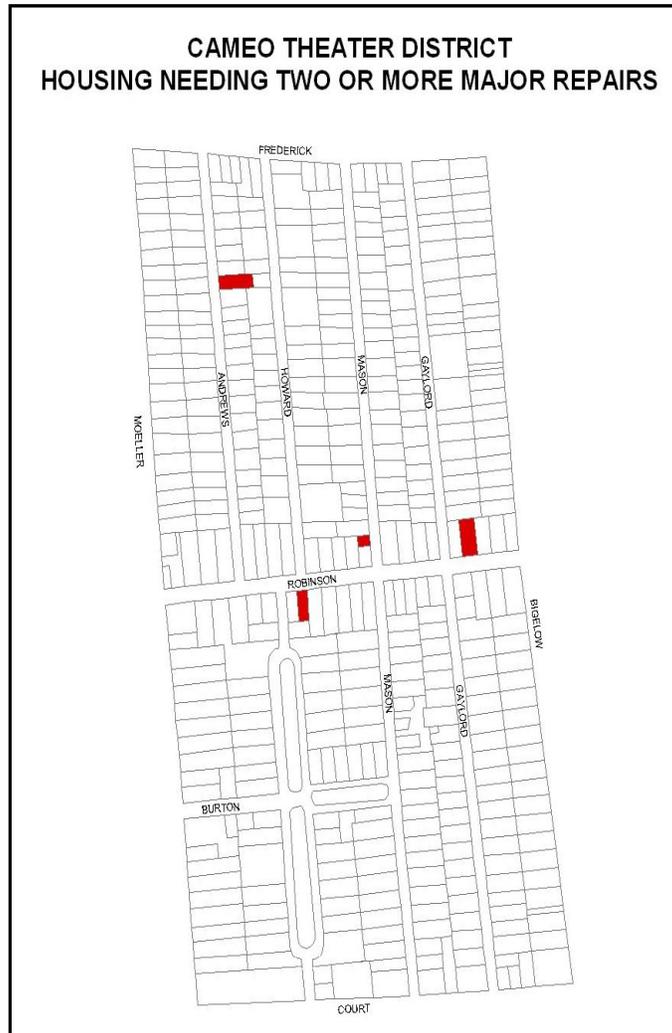
Figure 6.11 Properties Needing Two or More Major Repairs

Finally, there are only four houses in this area that need two or more major repairs (Figure 6.11) and are considered seriously deteriorated. These structures need significant work or demolition.
