**LEROY STREET
ROAD SAFETY ASSESSMENT**

**CITY OF BINGHAMTON
BINGHAMTON METROPOLITAN TRANSPORTATION STUDY
AUGUST 2024**

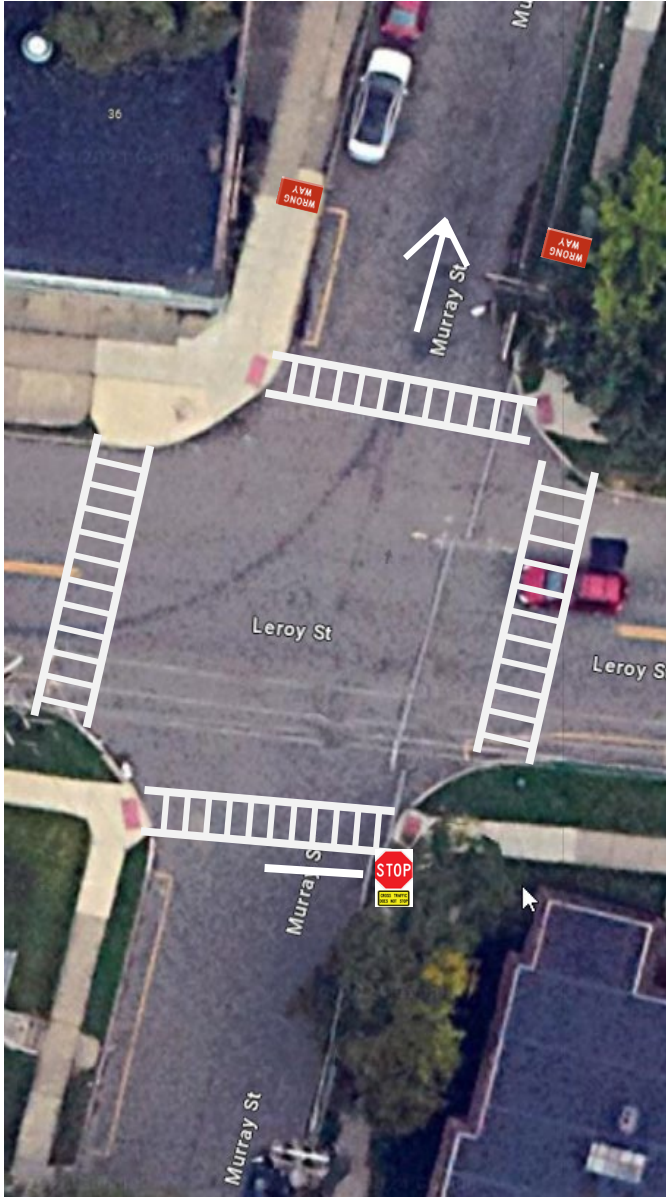
Murray Street and Leroy Street

Traffic controlled by Stop Signs on Murray. Murray Street in one-way northbound north of Leroy Street. 12 total reported crashes, 6 of which were vehicles from north bound Murray failing to yield right-of-way to Leroy Street.

4. Add 'No Parking Here to Corner' signs and associated pavement markings at all approaches, marking and signage are either missing or noncompliant with setbacks at some of the intersection approaches. The no parking setbacks should be measured from the crosswalks

9. Repair trip and fall hazards of sidewalks

1. Install a traffic calming element - Raised Intersection (recommended), Traffic Circle, or curb extensions – see Attachments A, B, C
2. Re-evaluate for all-way stop

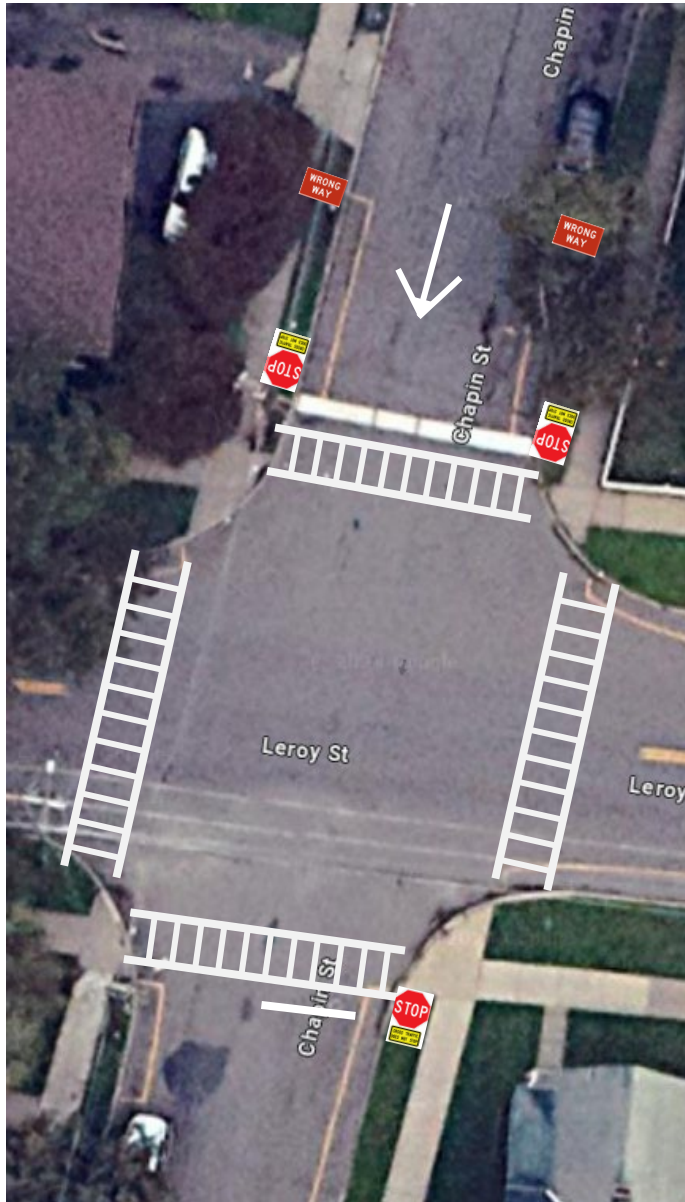
Chapin Street and Leroy Street

A member of the walking audit team indicated that they have difficulty seeing oncoming traffic at this intersection whether they are on foot or in a vehicle, due to vehicles parked along Leroy Street. A large shrub at the northwest corner of Leroy Street was also observed to be blocking sight lines during the audit. Many of the vehicle operators involved in crashes reported that they were unable to see oncoming traffic, therefore lack of adequate sight distance is likely a contributing factor to at least some of the right-angle crashes.

Traffic controlled by Stop Signs on Chapin. Chapin Street in one-way southbound north of Leroy Street. 12 total reported, 8 of which were vehicles from Chapin failing to yield right-of-way to Leroy Street (5 striking eastbound traffic and 3 striking westbound traffic). All crashes during daylight hours except 1.

3. Add 'No Parking Here to Corner' signs and associated pavement markings at all approaches, marking and signage are either missing or noncompliant with setbacks at some of the intersection approaches. The no parking setbacks should be measured at least from the crosswalks. Given the crash history consider extended the no parking areas beyond the 30-foot minimum to the nears intersecting driveways

8. Repair trip and fall hazards of sidewalks

1. Install a traffic calming element - Raised Intersection (recommended), Traffic Circle, or curb extensions – see Attachments A, B, C
2. Re-evaluate for all-way stop

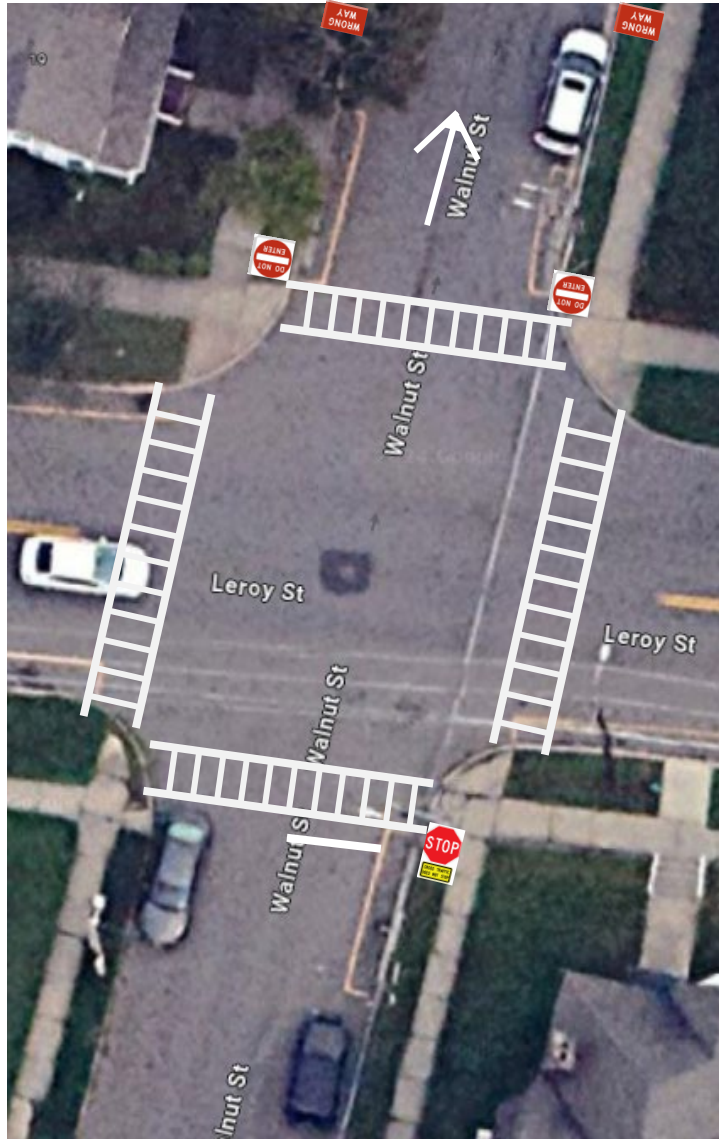
Walnut Street and Leroy Street

Traffic controlled by Stop Sign for northbound Walnut Street only. Walnut Street in one-way northbound north of Leroy Street.

9 total reported, 3 involved wrong way driving on Walnut entering Leroy Street, and two failure to yield. All crashes during daylight hours.

1. Upgrade Stop Signs on Chapin Street
 - Use Oversized Stop Signs
 - Add retroreflective strips on signposts
 - Add 'Cross Traffic Does Not Stop' (W4-4p) supplemental placard
 - Add stop bar
2. Add Do Not Enter (R5-1) and Wrong Way signs (R5-1a) on Walnut Street facing north board and consider a wrong-way arrow north of Leroy Street
3. Add 'No Parking Here to Corner' signs and associated pavement markings, marking and signage are either missing or noncompliant with setbacks at some of the intersection approaches
4. Add 'Cross Traffic Does Not Stop' (W4-4p) supplemental placard to Stop Sign
5. Add retroreflective strips on Stop signpost
6. Add ADA compliant curb ramps across all four legs of the intersection
7. Add high visibility ladder style crosswalks across all 4 legs of the intersection
8. Repair trip and fall hazards of sidewalks

1. Install a traffic calming element - Raised Intersection (recommended), Traffic Circle, or curb extensions – see Attachments A, B, C
2. Re-evaluate for all-way stop

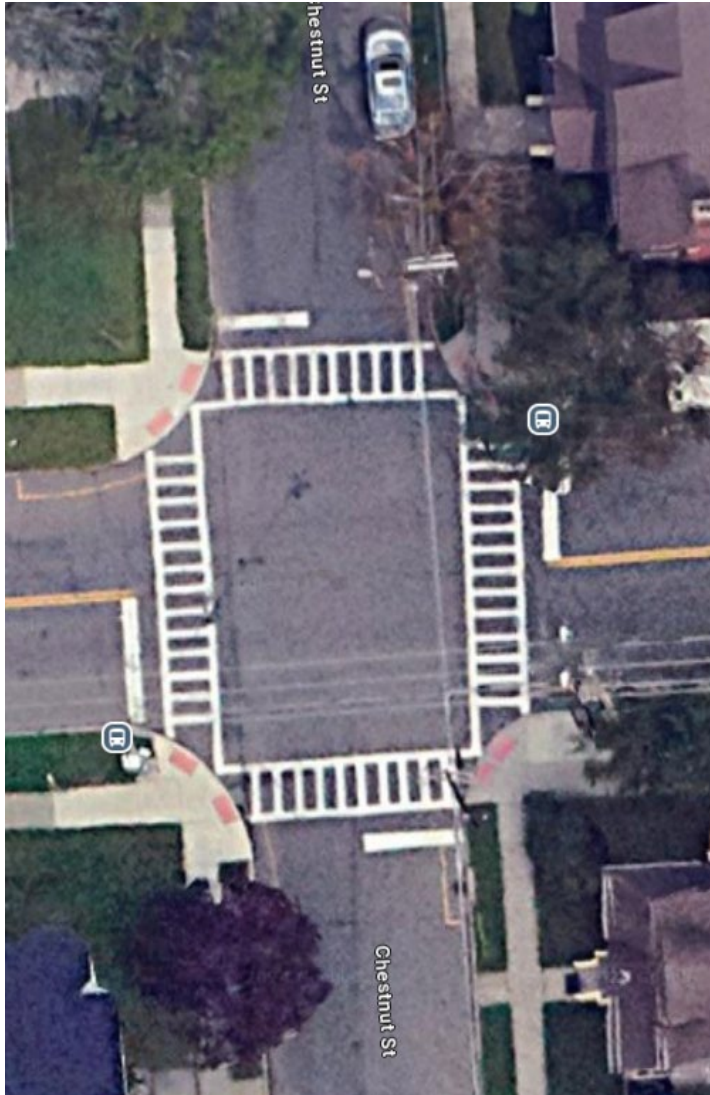
Chestnut Street and Leroy Street

Four-way stop-controlled intersection controlled with a traffic signal
15 total reported crashes however there was no clear crash pattern other than striking of parked vehicles

1. Add 'No Parking Here to Corner' signs and associated pavement markings, marking and signage are either missing or noncompliant with setbacks at some of the intersection approaches
 - parking is prohibited within 30 feet of an intersection per the City's Vehicle and Traffic Code

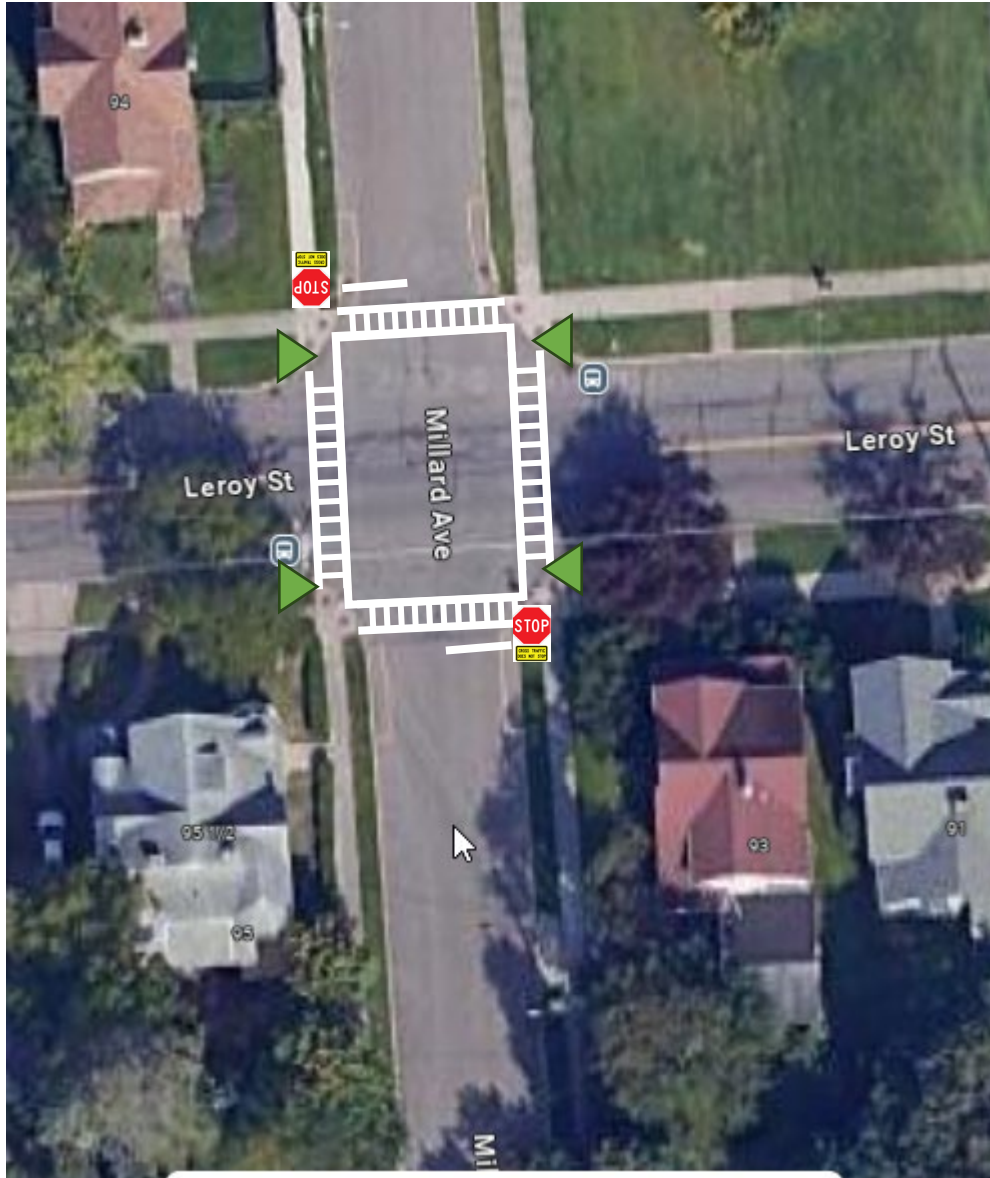
Millard Ave and Leroy Street

A large shrub at the southeast corner of Leroy Street was also observed to be blocking sight lines during the walking audit. Since the right-angle crashes involve northbound vehicles failing to yield the right of way to west bound vehicles it is feasible that the shrub is blocking sight distance. Lower branches of a tree to the east of the intersection may also impede views looking eastbound toward westbound traffic. Smaller shrubs at the southwest corner may also impede views of vehicles with lower vertical clearance.

Two-way stop-controlled intersection, with stop signs controlling north and southbound Millard Ave
6 total reported crashes between June 2021 and June 2024

- 4 were right angle – vehicles heading northbound of Leroy failing to yield ROW to vehicles traveling on Leroy

1. Re-evaluate for all-way stop
2. Install a traffic calming element - Raised Intersection (recommended), Traffic Circle, or curb extensions – see Attachments A, B, C

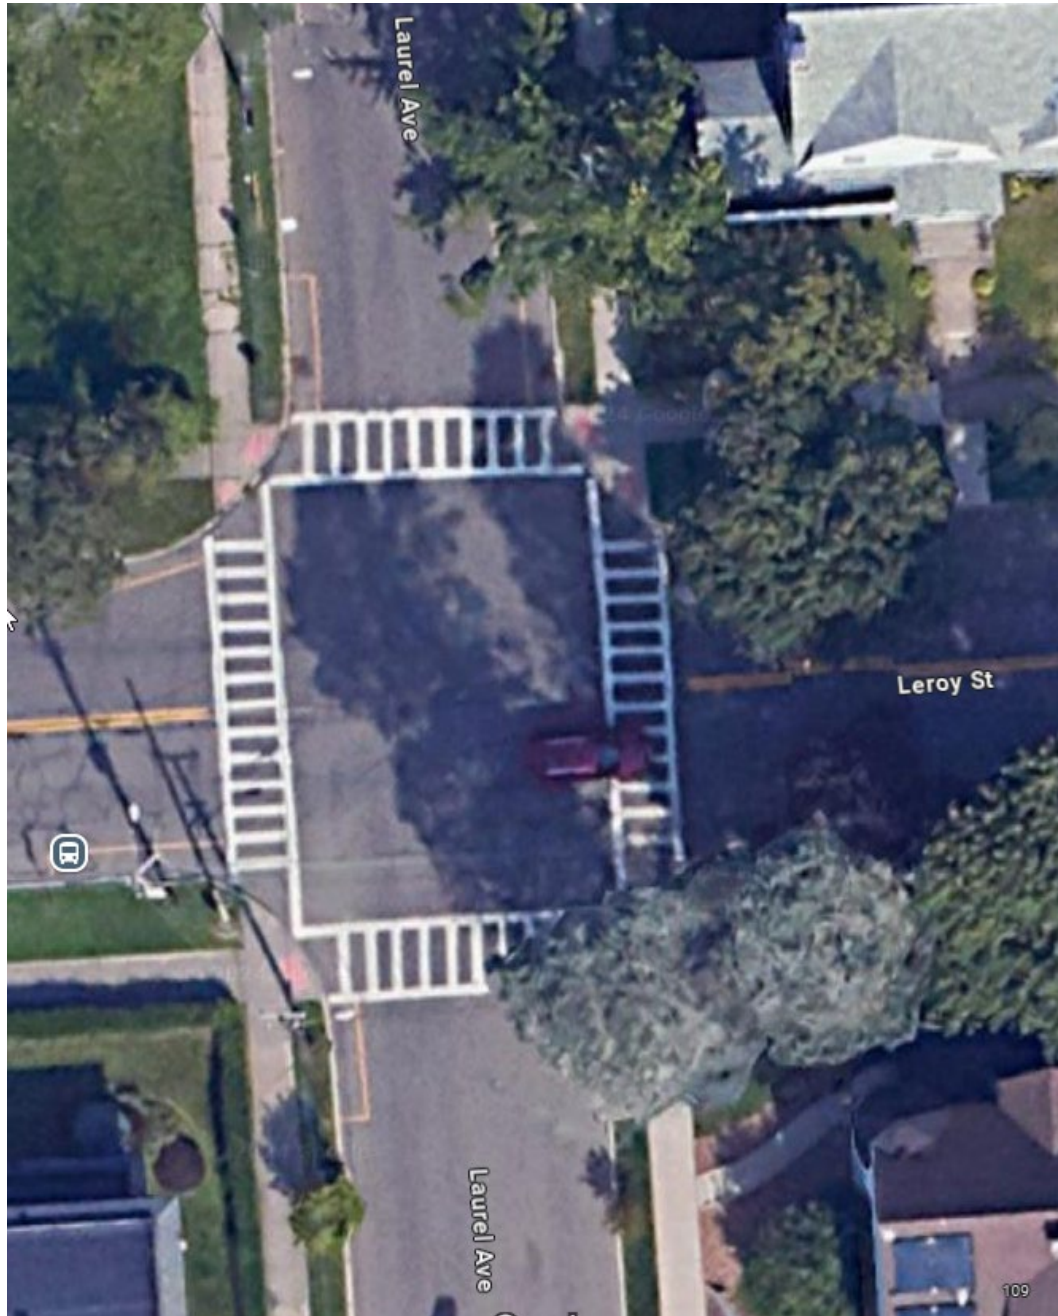
Laurel Ave and Leroy Street

All-way stop-controlled intersection, with ladder-style painted crosswalks at all approaches. One crash over the 3-year study period.

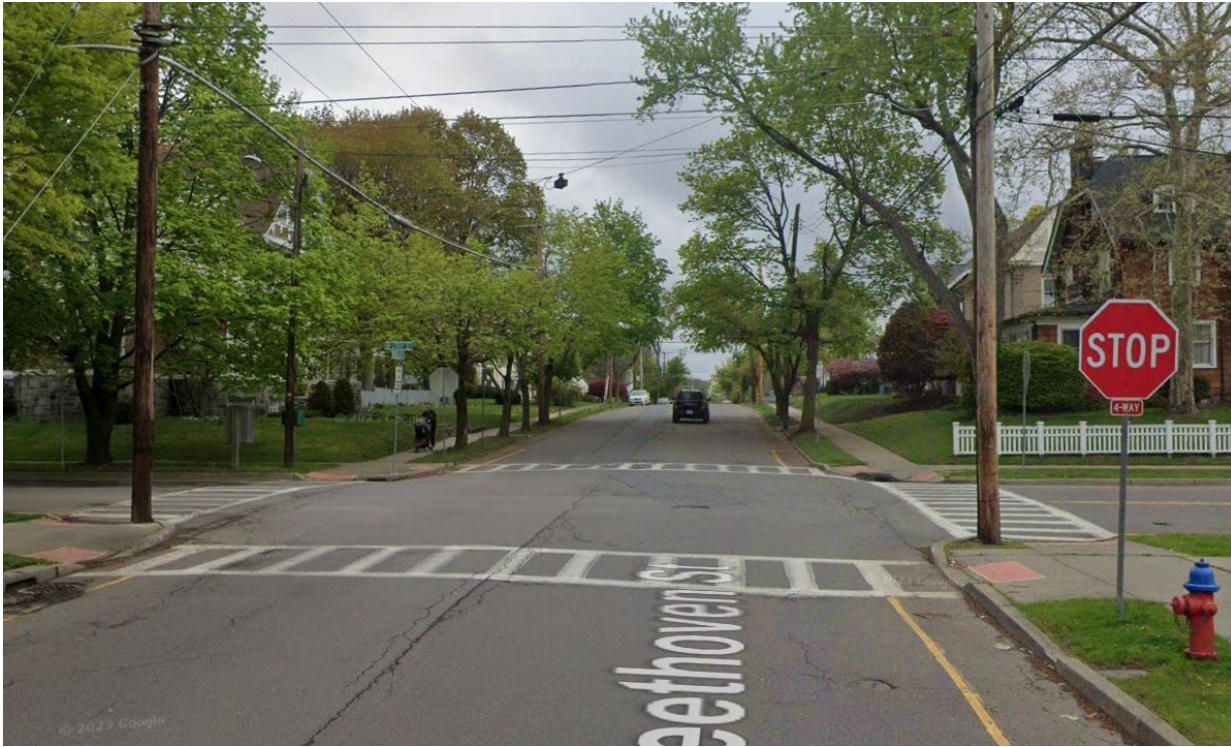
Beethoven Street and Leroy Street

All-way stop-controlled intersection, with ladder-style painted crosswalks at all approaches. 3 crashes all right angle caused by north bound vehicles on Beethoven failing to yield the right-of-way.

4. Verify curb ramps are ADA compliant and upgrade as necessary

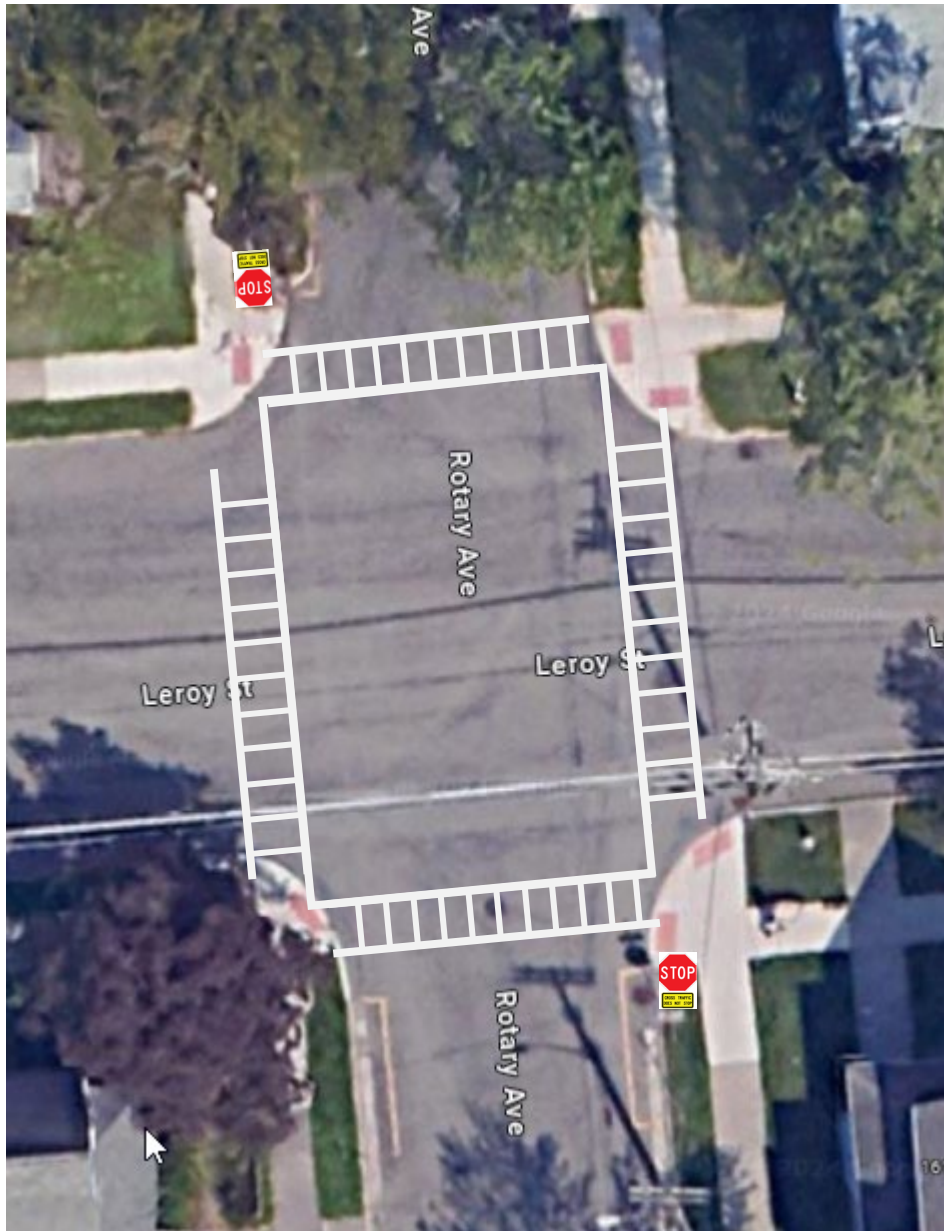
Rotary Avenue and Leroy Street

Two-way stop-controlled intersection, with stop signs controlling north and southbound Rotary Ave. No crashes reported during the study period.

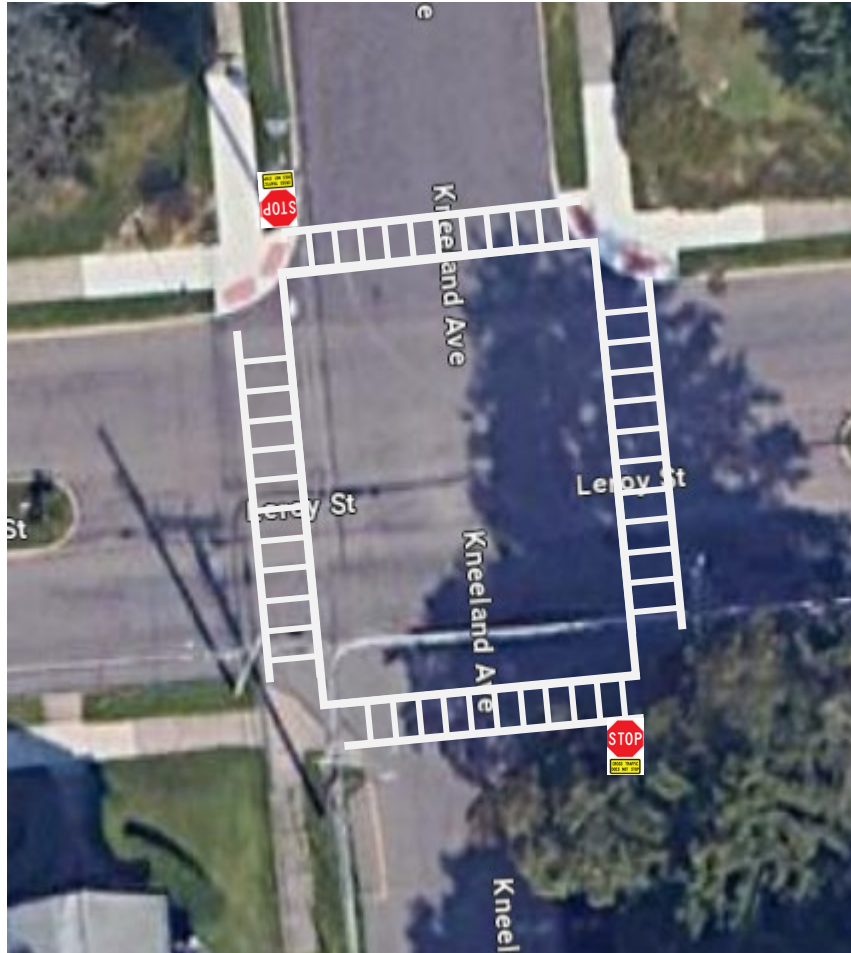
Kneeland Avenue and Leroy Street

Two-way stop-controlled intersection, with stop signs controlling north and southbound Kneeland Ave. Two crashes reported during the study period, one northbound and one southbound from Kneeland failing to yield right of way.

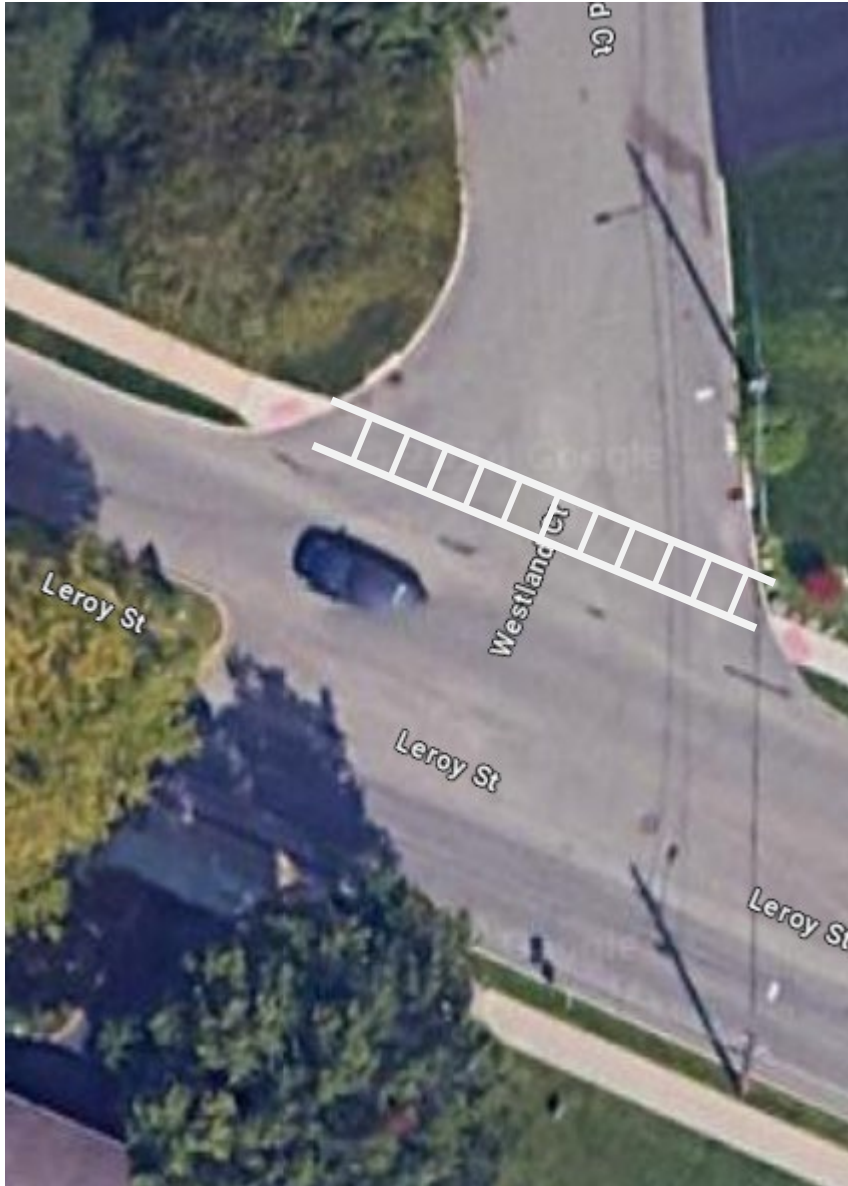
Westland Court and Leroy Street

T intersection, with a stop sign controlling Westland. No crashes reported

1. Add a high visibility ladder style crosswalk Westland
2. Shrubs located in the traffic island from Westland to Helen have been trimmed to below 3 feet in height, this should be maintained.

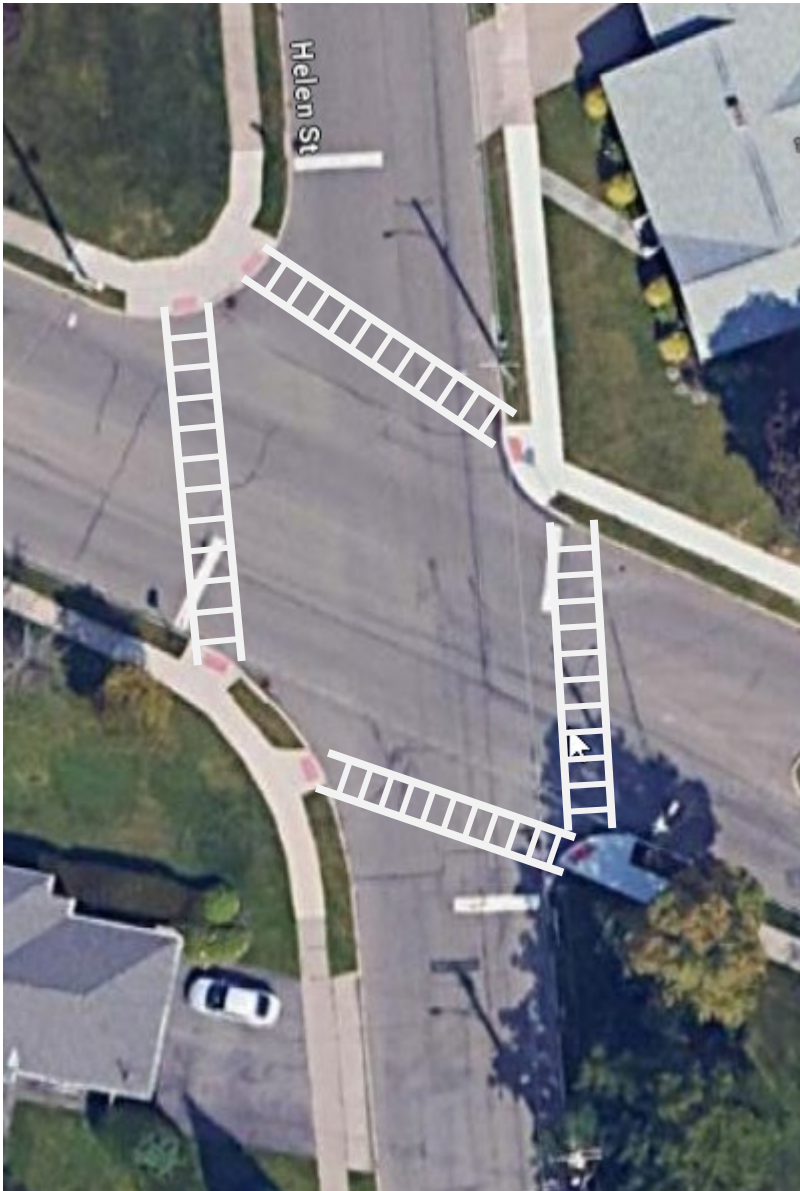
Helen Street and Leroy Street

Skewed all way stop intersection. No crashes reported.

1. Add missing curb ramps on Leroy east of Helen
2. Add curb ramps on Leroy Street east of Helen
3. Add a high visibility ladder style crosswalks across all four legs of the intersection
4. Relocate the stop line on the Helen Street southbound approach to be closer to the intersection but behind the crosswalk. Relocate the other stop lines as necessary to accommodate crosswalks
5. In conjunction with relocated the stop line relocate the stop sign closer to the intersection
6. Maintain height of shrubs in the traffic islands between Helen and Crestmont below 3 feet.

1. When a street reconstruction occurs on Leroy/Helen consider extending the curb lines so that the intersection is less skewed

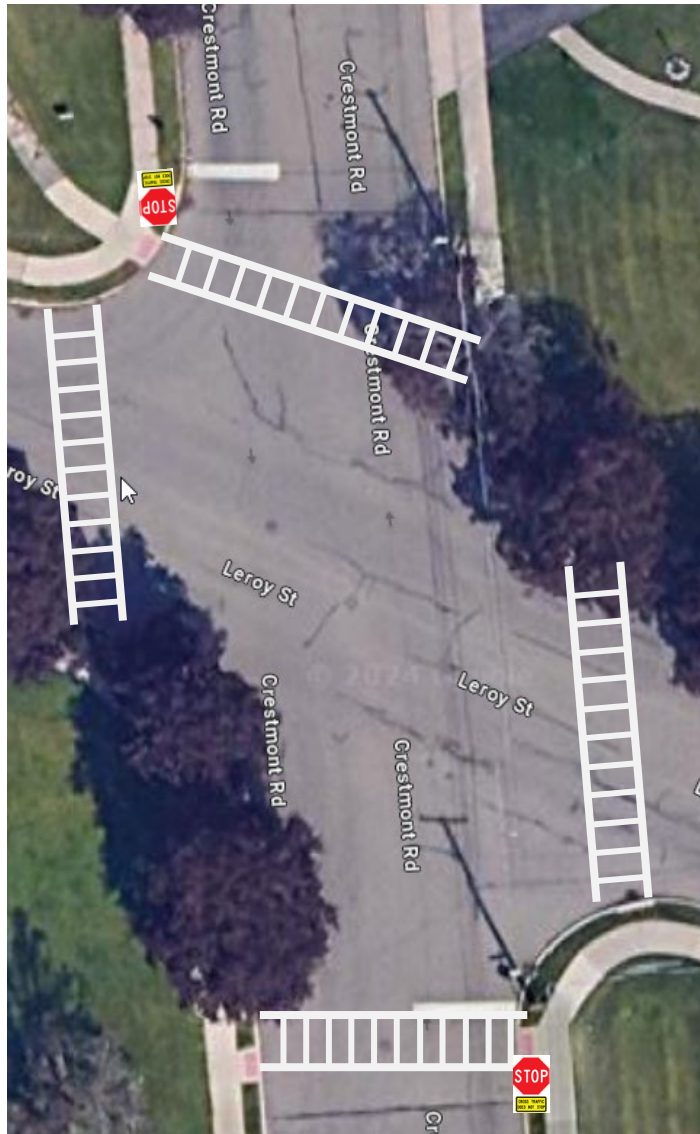
Crestmont Road and Leroy Street

Skewed two way stop intersection, with Crestmont Road controlled with a stop sign. 3 crashes, two of which were right angle caused by northbound Crestmont vehicle failing to yield right-of-way
