Department of Planning, Housing, & Community Development

Date: 19 August 2013
To: Commission on Architecture & Urban Design Members
Subject: **33 Oak Street – Window**
Tax ID: 160.55-2-24
Case: CAUD 2013-28
Copies: T. Costello; C. Fenson; file

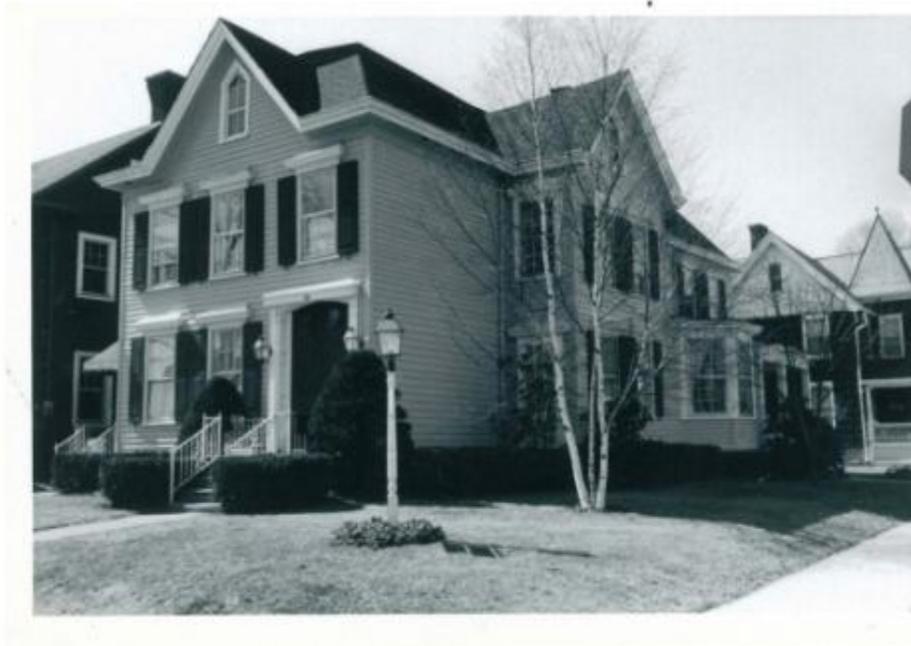
March 1979

Photographic evidence shows that the location of the installed window was at one point a doorway (see 1979 photograph); however, that doorway was closed off sometime before 2006 (see 2006 photograph).

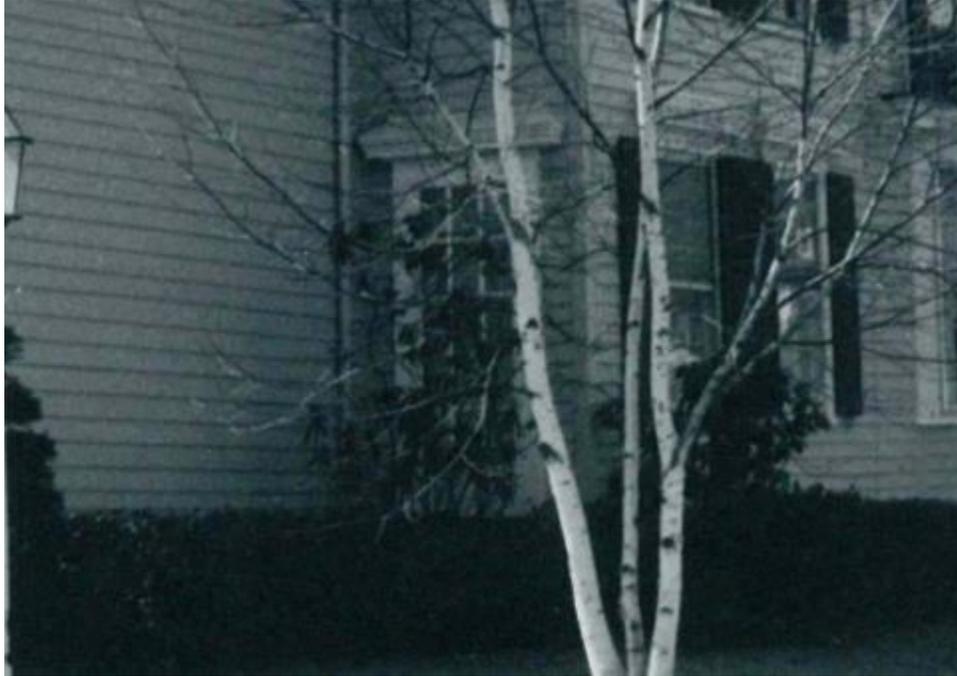
Detail of March 1979 photograph, showing the doorway

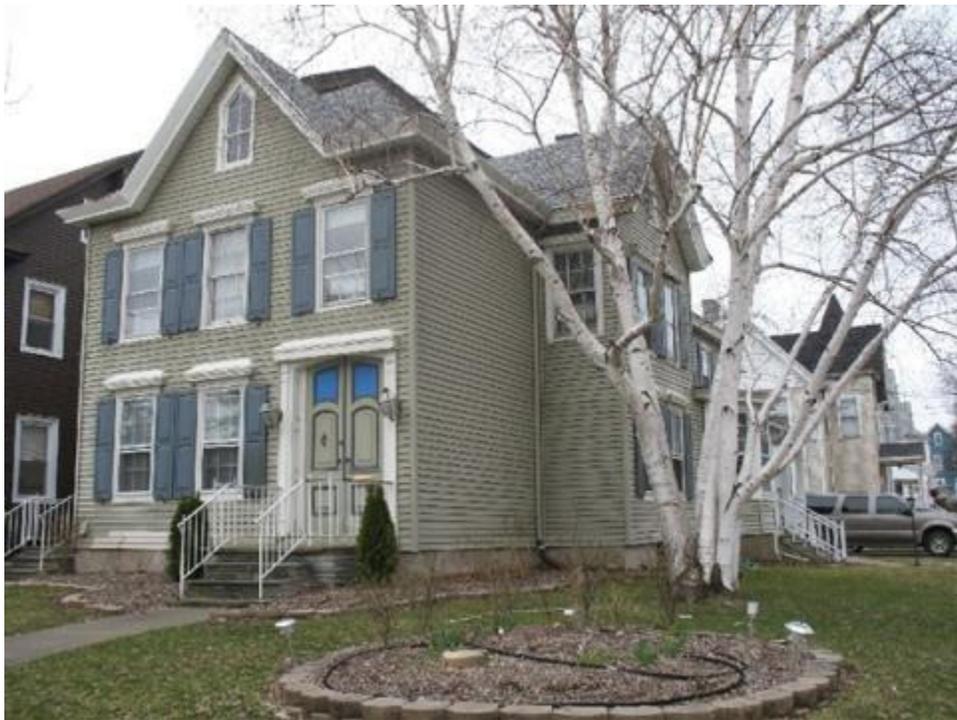
2006 photograph, showing the doorway removed, sided over

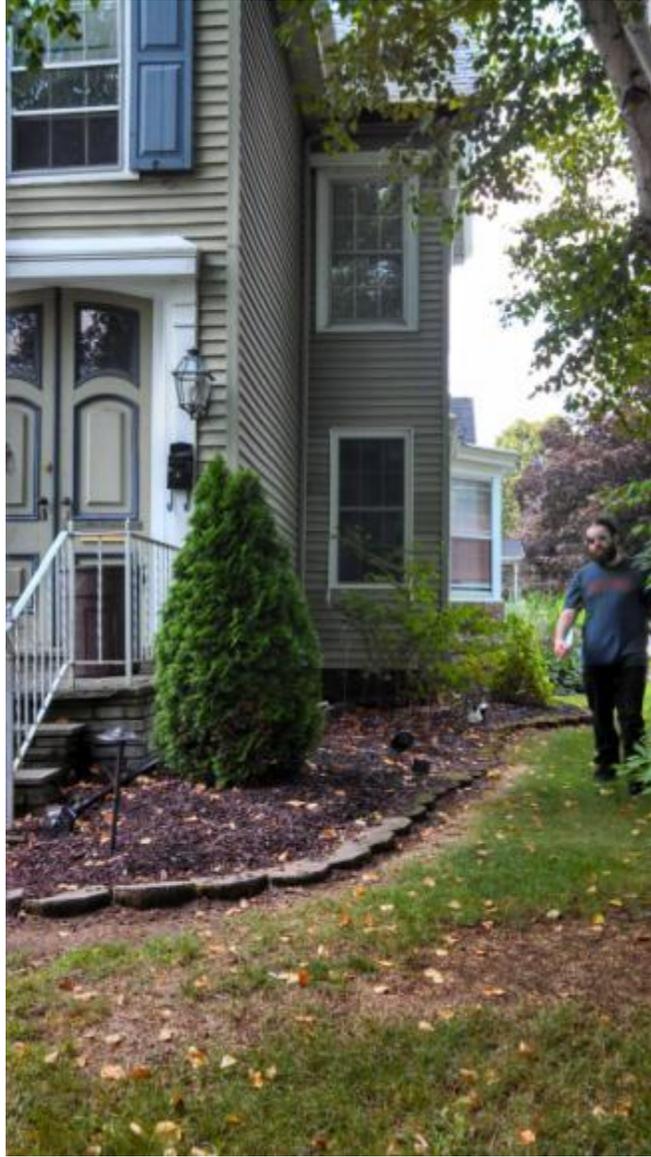
13 August 2013

The window as installed, however, was not done in an appropriate manner. The window was not installed in line with the window on the upper floor, and the window which was installed is not the same width as the window on the upper floor (see the August 13, 2013, photograph).

Staff's recommendation would be that, if the Commission decides to find that the installation of a window in this located is appropriate, that the Commission impose the following requirements for approval:

1. That the new window be the same width and height as the existing window on the upper story;
2. That the new window be installed to line up with the existing window on the upper story; and
3. That the new window be trimmed out to match the existing window on the upper story.

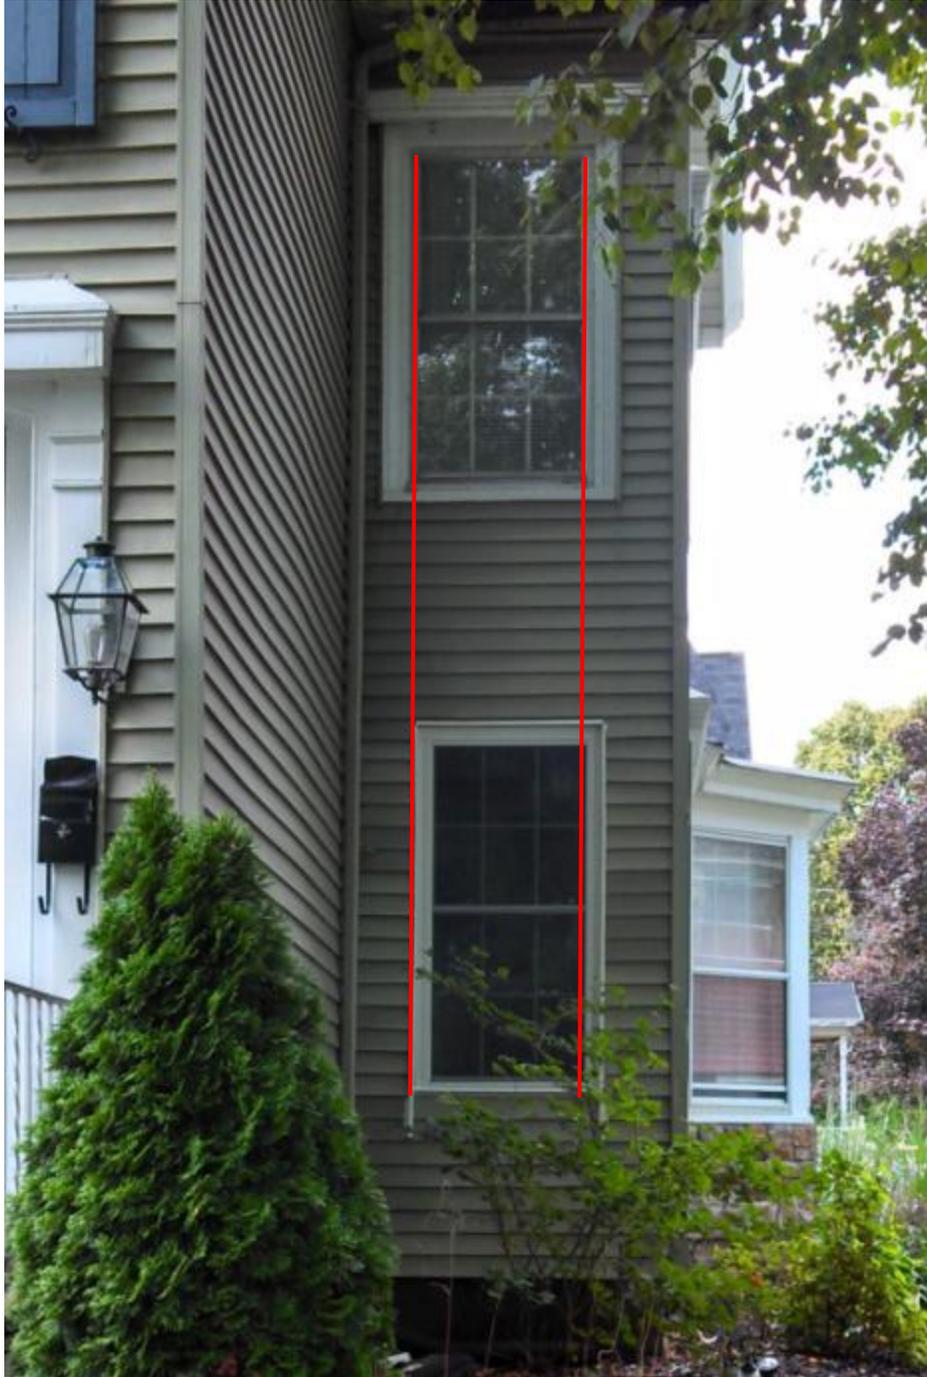
Detail of 13 August 2013 photograph – notice the lack of alignment between the two windows; the red lines are drawn along the sash frame of the upper window
