6.0.0 HOUSING QUALITY REPORT

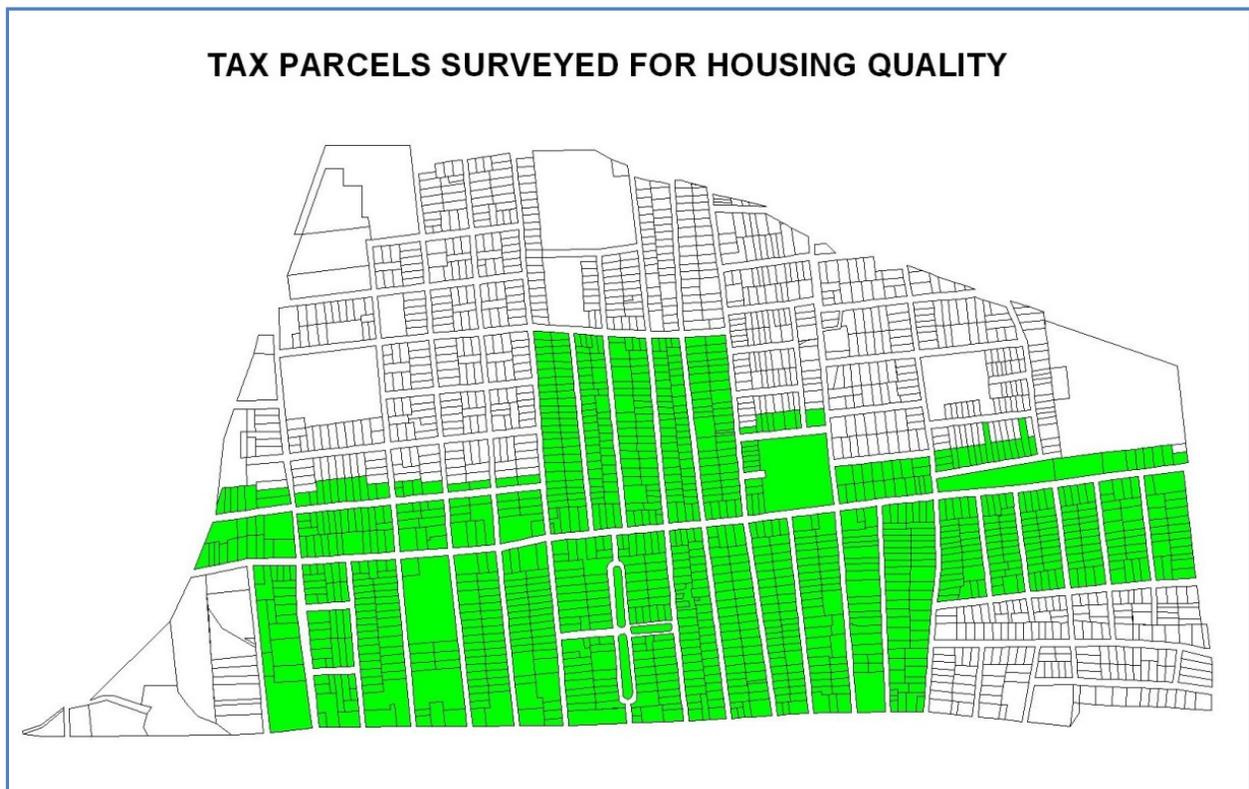
Figure 6.1 Tax Parcels Surveyed for Housing Quality

Because the focus of this study is the conditions along the Robinson Street corridor, the housing quality survey was limited to one block on either side of Robinson Street. Many of these blocks are quite long and as a result fully half of the total area of the East Side was surveyed (Figure 6.1). Specifically, of the 1,839 residential parcels in the East Side (including parcels that contain commercial as well as residential land uses) 1,035 or 56% were included in this survey.

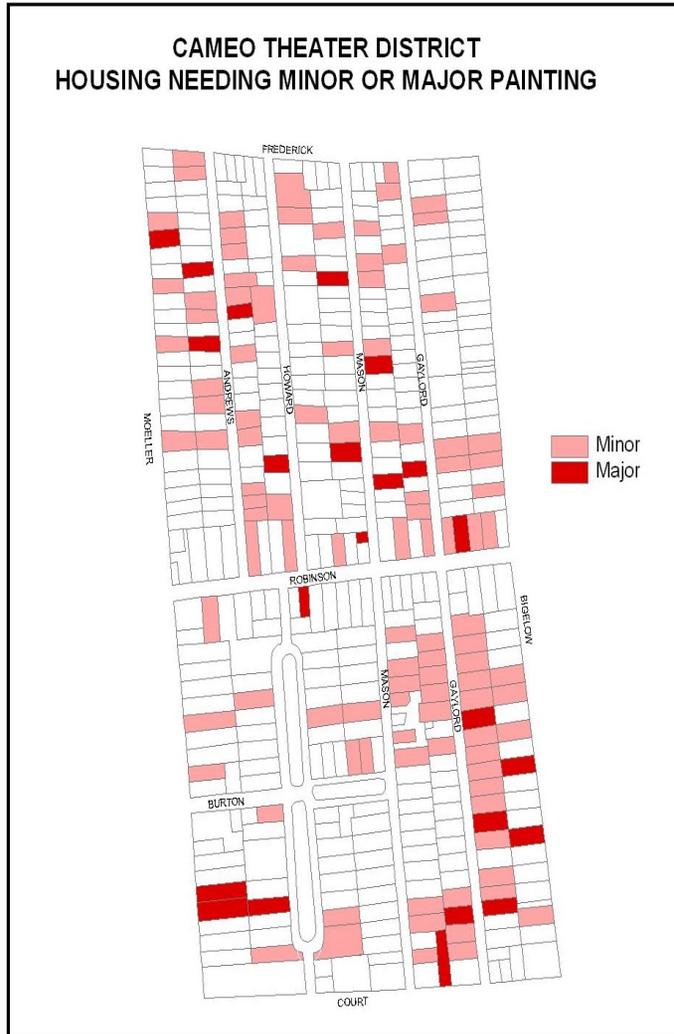
Figure 6.7 Properties Needing Minor or Major Painting

Findings from the Neighborhood Assemblies and the resident and business surveys lead to the creation of the Cameo Theater target area for increased focus and analysis (See Section 10.0). The following maps and analysis will focus on the housing quality in the Cameo Theater area. Generally speaking the observations made in the previous section are also true of the Cameo Theater Area. Houses needing paint or siding repair are scattered throughout the area but show some clustering (Figures 6.7 and 6.8), again allowing for a targeted approach for rehabilitation. It is interesting to note that the houses on Howard Avenue, a street that has been closed to through traffic from Court Street, have been very well maintained. There are many fewer houses that need three or more minor repairs, or one major repair. They are scattered around the focus area, with several adjacent to one another (Figures 6.9 and 6.10).
