Department of Planning, Housing, & Community Development

Meeting Date: 29, December 2015
Sent To: Commission on Architecture & Urban Design Members
Subject: **21 Chenango Street – Request for Temp. Signage Extension**
Tax ID: 160.41-1-13.1
Case: CAUD 2015-52

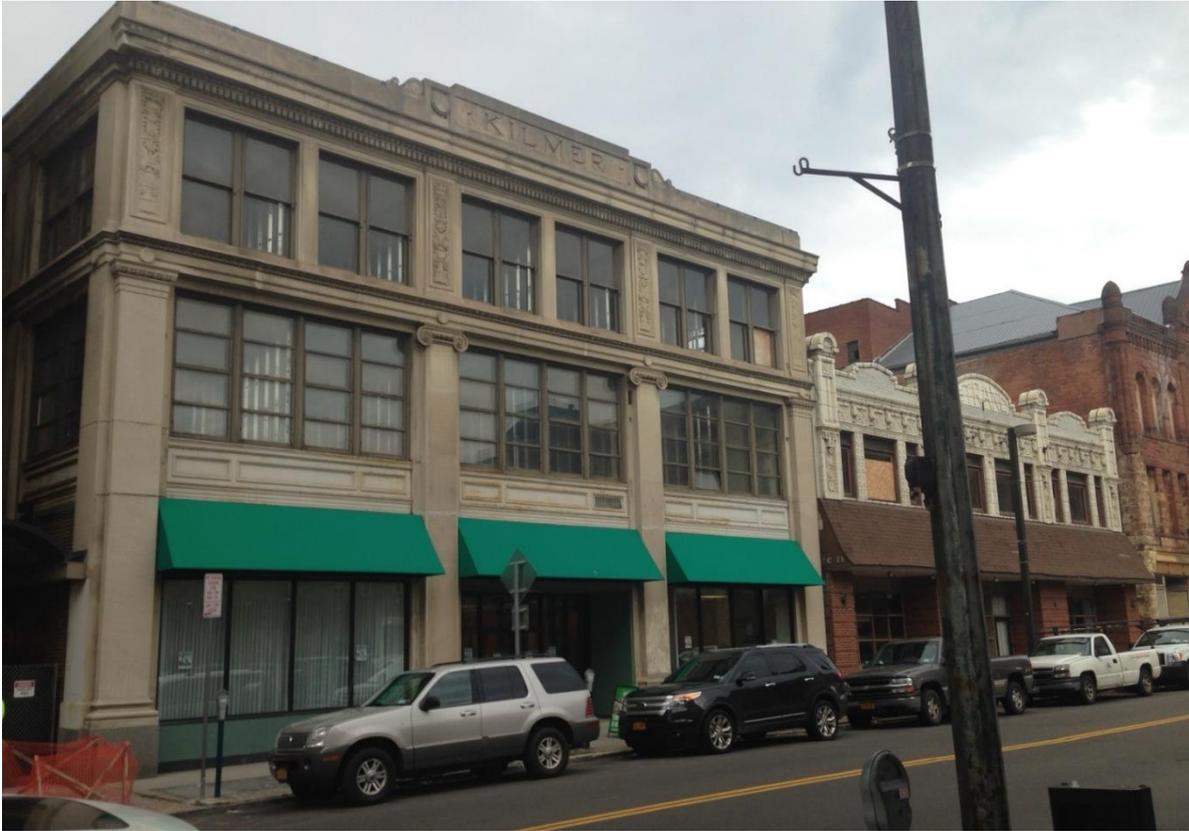
Site conditions (21 October, 2015)

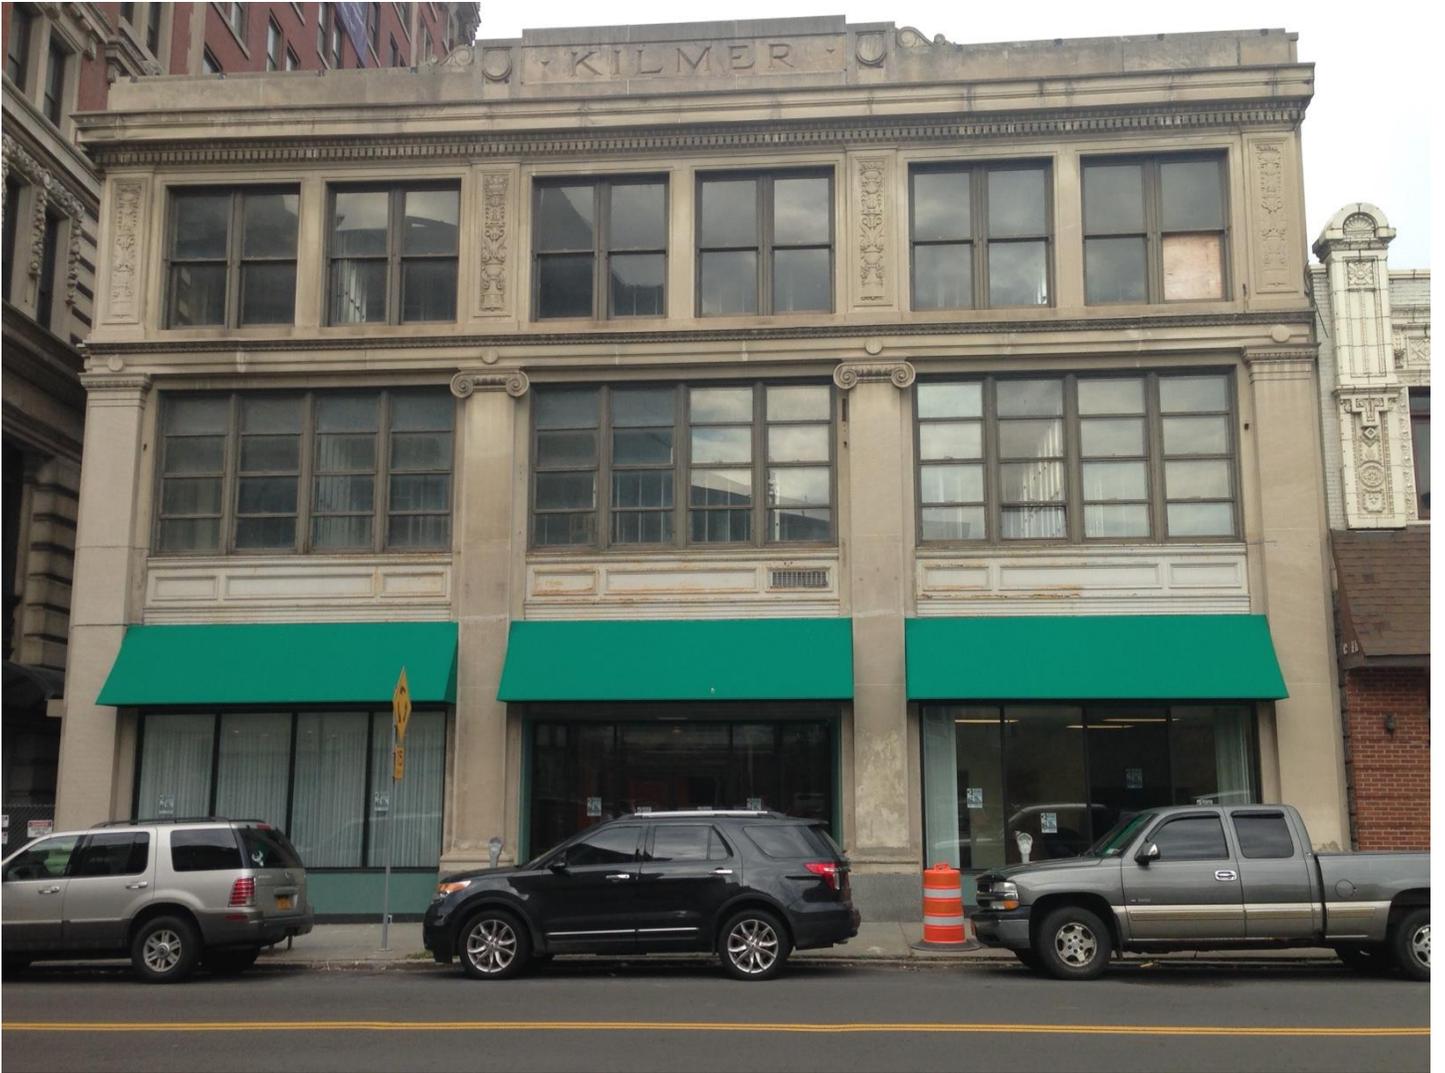
Site conditions (21 October, 2015)

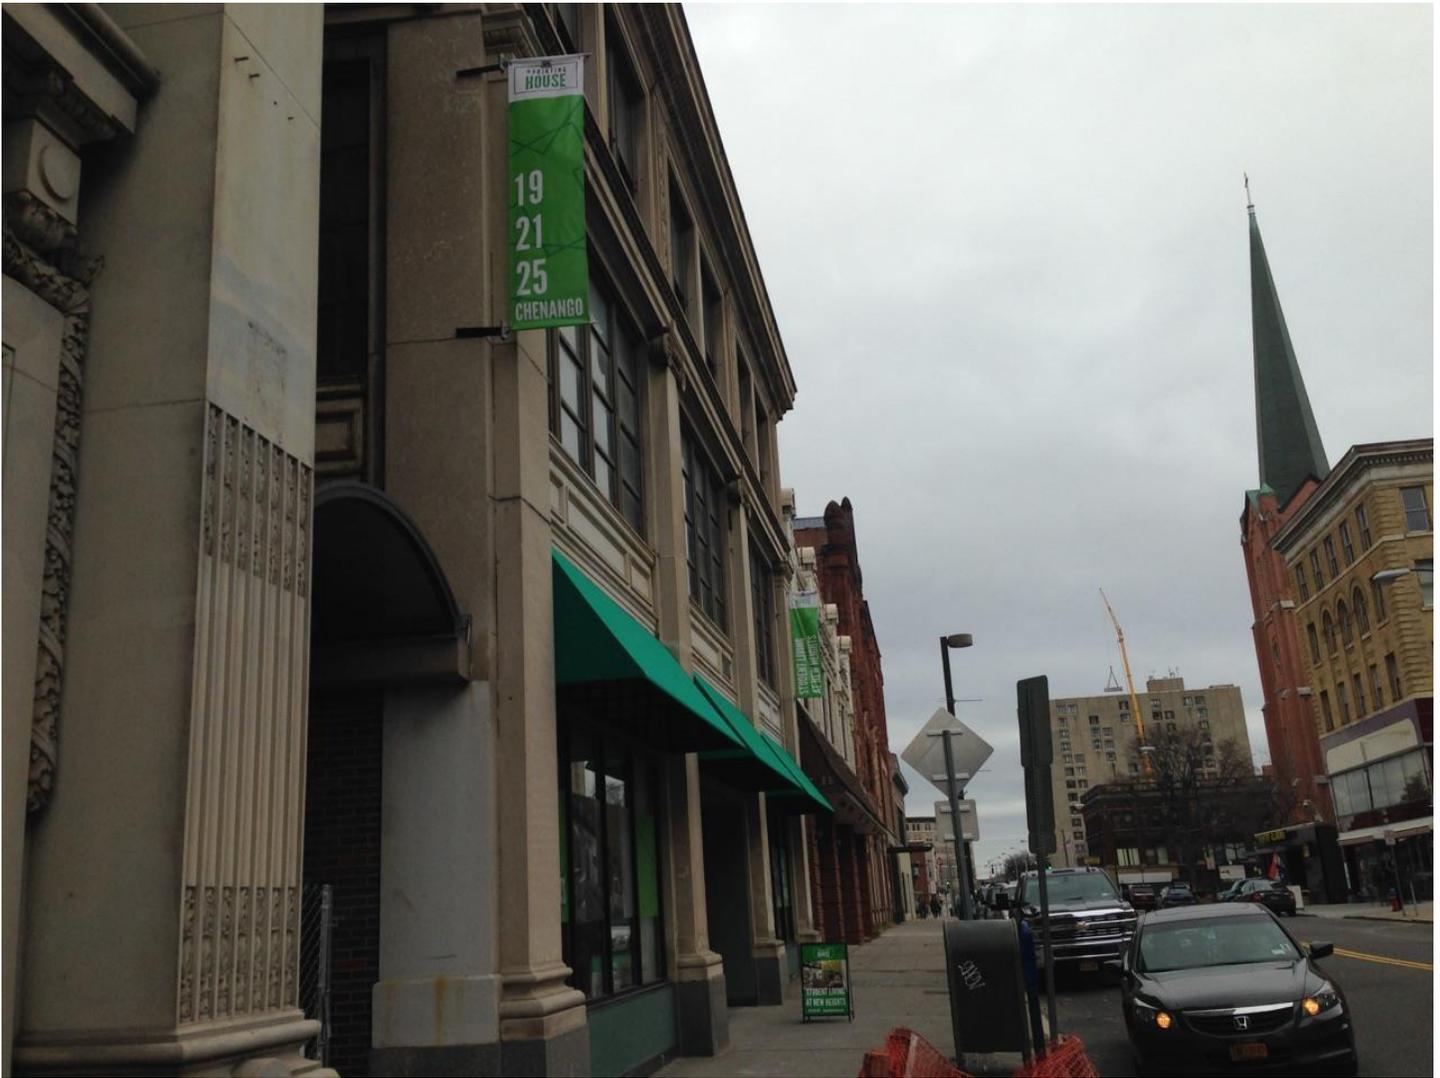
The Applicant did not install the banner signage as proposed in the 27 October, 2015 CAUD meeting, making it out of compliance with zoning code, and in violation to the decision made at CAUD's October meeting. One (1) projecting banner sign is allowed per façade. The Applicant has placed two (2) projecting banner signs on the east, Chenango Street façade. The proposal showed that one of the projecting banner sign would be placed over Press Ally on the south façade.

Current Conditions: notice the non-compliant projecting banner signage, not consistent with the Applicants previous proposal and the CAUD Approval decision. (November 18, 2015)

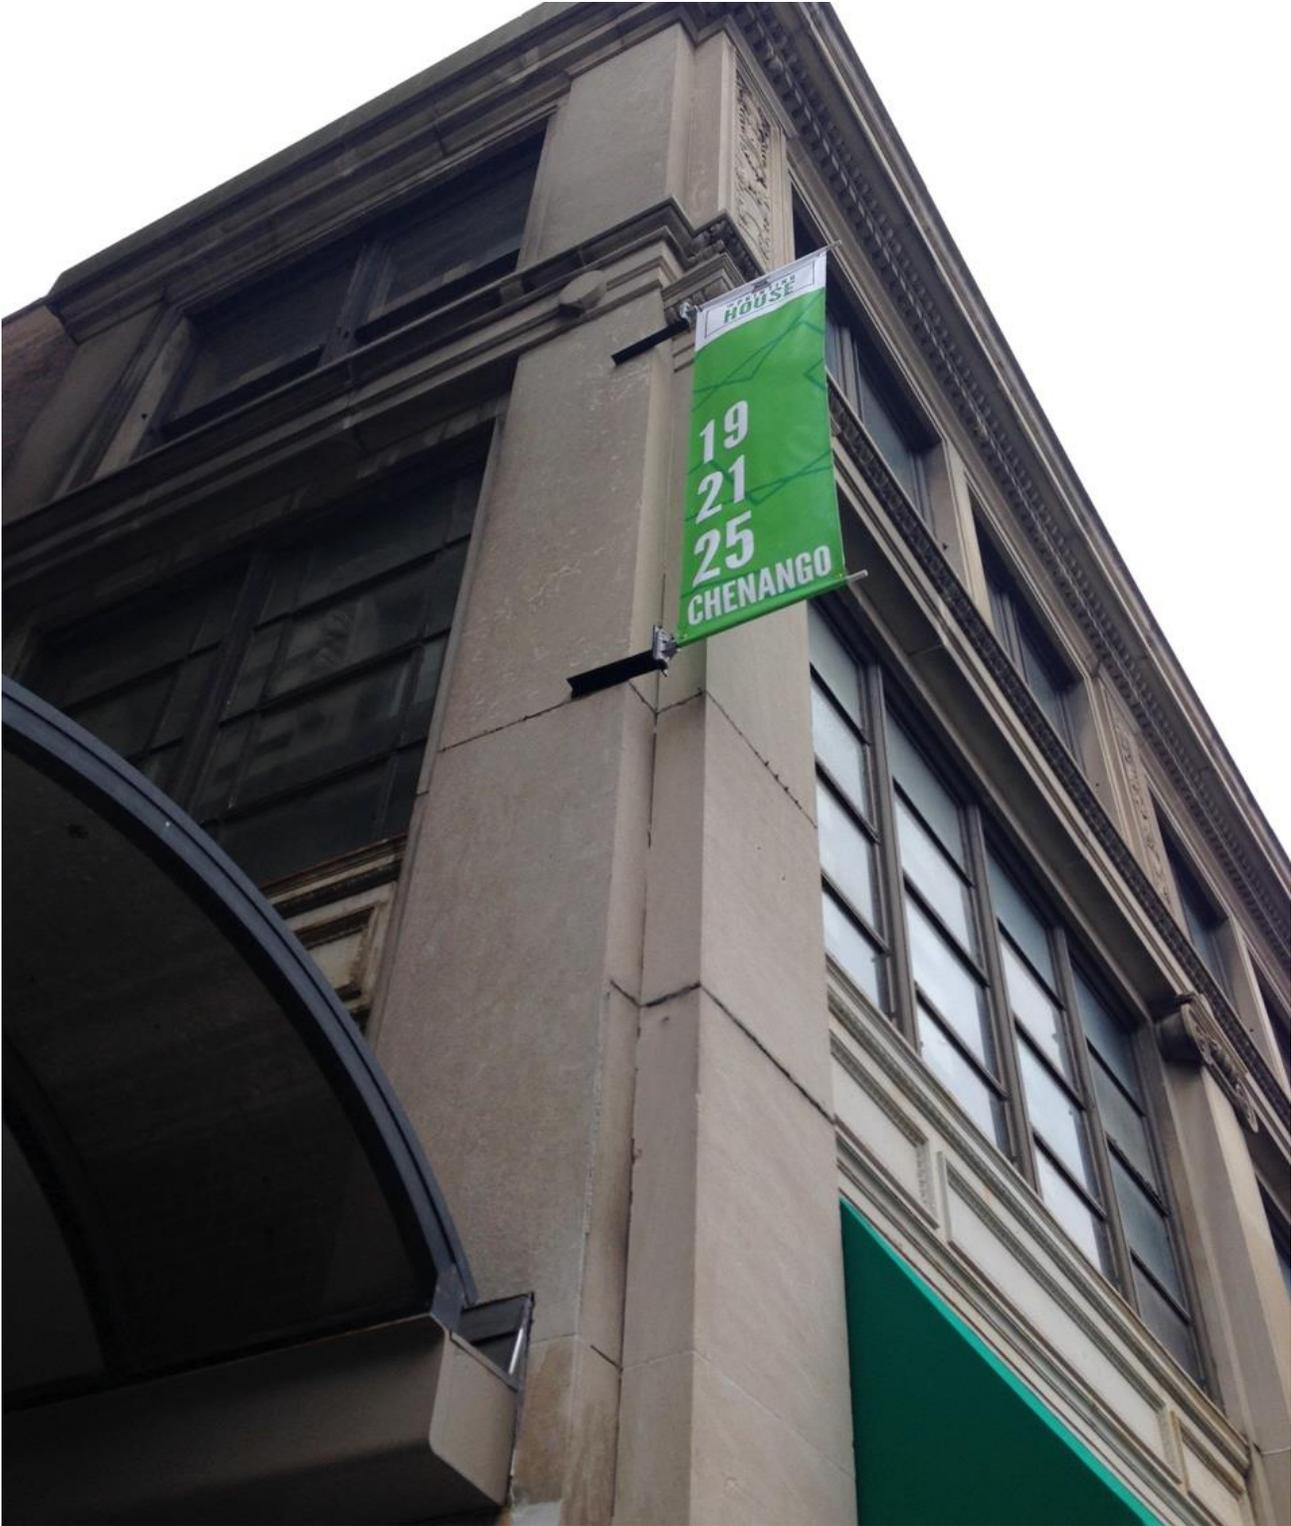
As an update to the project implementation, the Commission should note that condition one (1), listed in section "B" above was violated with the installation of a projecting banner sign attached to the east facing façade rather than the south façade as was agreed upon and approved at the October meeting. The banner was also drilled directly into the stone façade of the building rather than mounted from the mortar joints as specified by the conditional approval.

Photo detailing banner signage drilled directly into the façade in violation with the conditional approval of October 27th (November 18, 2015)

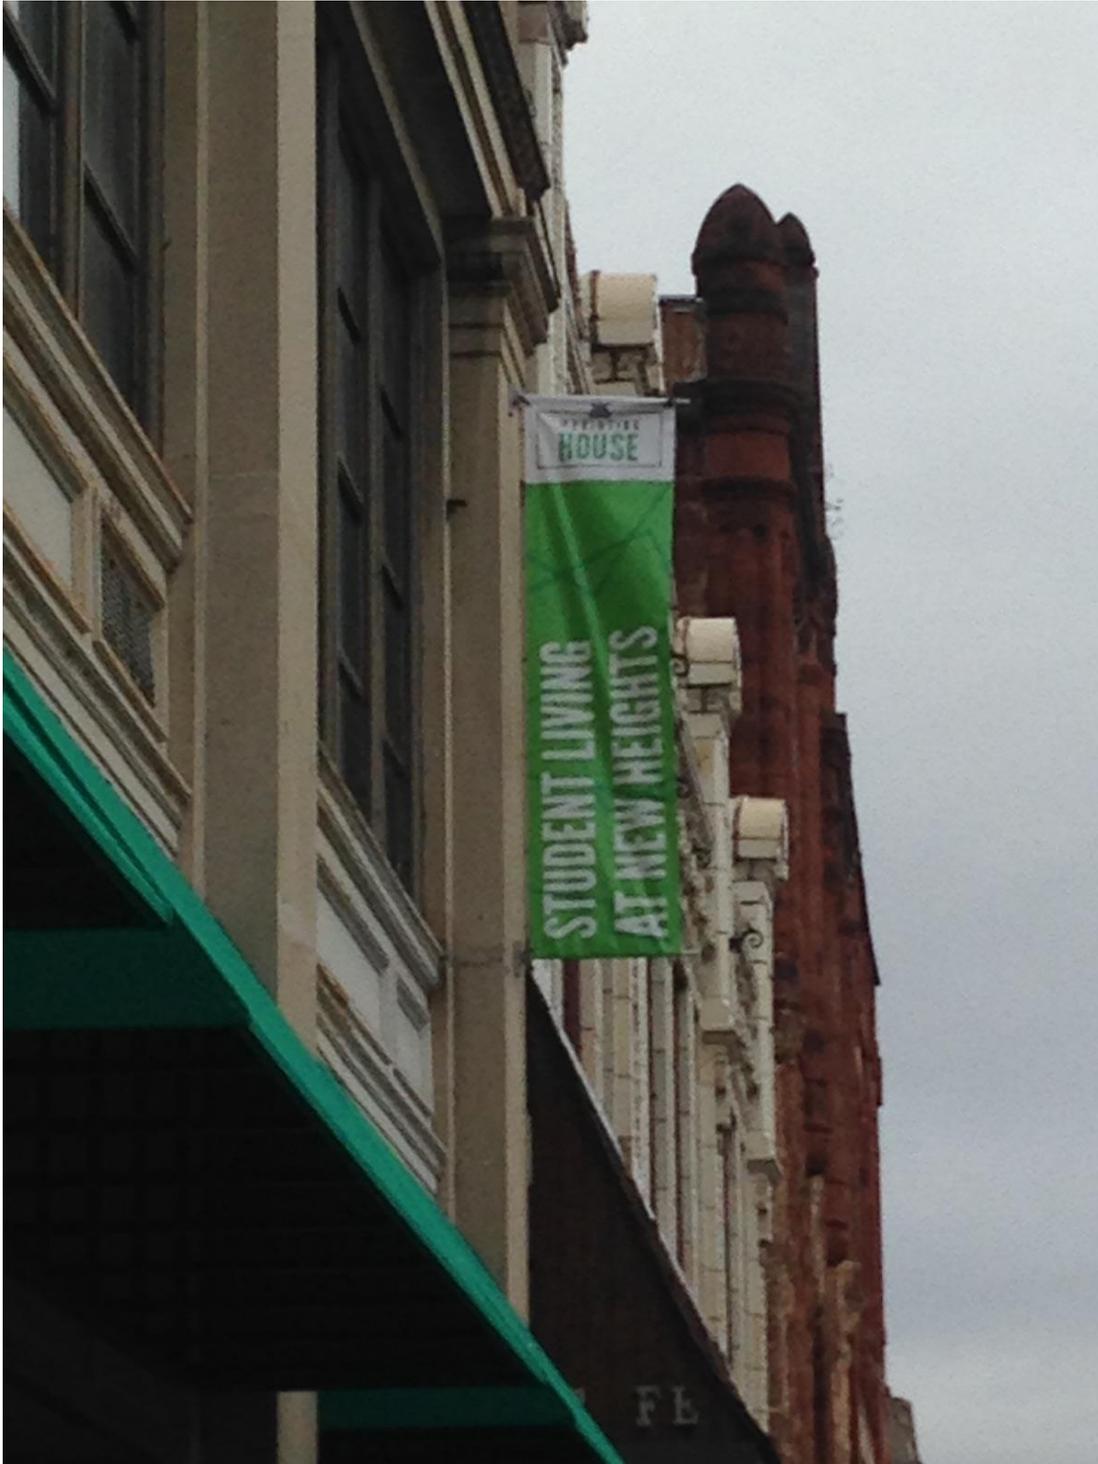
Another detailing of conditional approval violation – drilled into the stone facing of the building rather than mortar joints as specified in the decision. (November 18, 2015)
